TEST KIT FERROXYL

Whether or not to pickle: the TEST KIT FERROXYL reveals embedded iron particles on stainless steel.

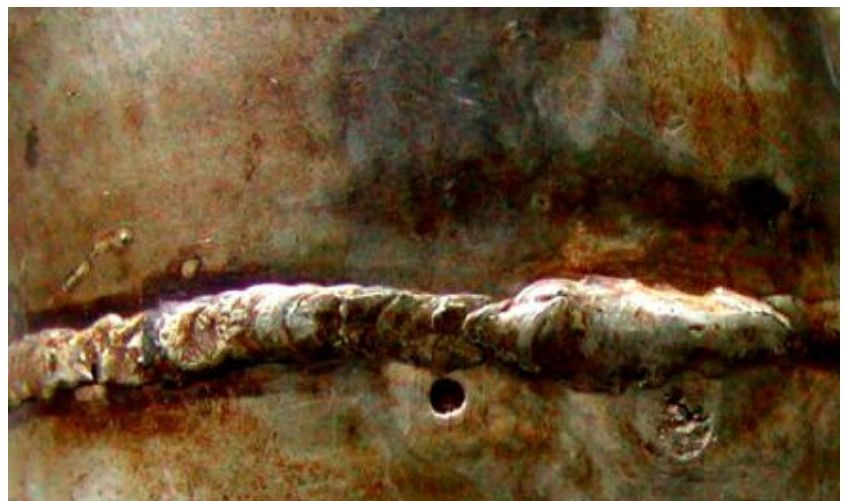
Example of pit corrosion caused by the presence of embedded iron

If the structure of austenitic stainless steel is contaminated with metallic iron (embedded iron) on the surface, the properties of the stainless steel will be adversely affected. The presence of embedded iron in the stainless steel surface disturbs the chromium oxide film, reducing the corrosion resistance locally.

When embedded iron is not removed, serious (pit) corrosion may set in.

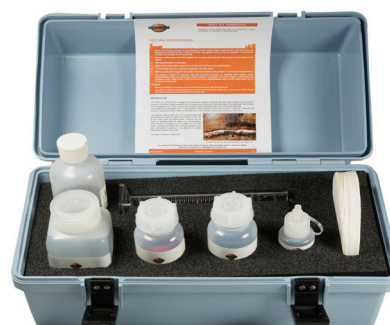
1. Place 5 measuring scoops Ferroxyl Reagent I in the mixing bottle. Augment this with 25 ml Ferroxyl Reagent II to the scale mark. Close the bottle and agitate until all Ferroxyl Reagent I is dissolved. Transfer the solution to the drop bottle.
2. Moisten a filter paper with this solution (ca. 5 drops) and place this filter paper on the surface to be tested.
3. Wait approximately 15 seconds.
4. When a blue colouration appears, it is evidence of surface iron contamination.
5. Finally, after removing the filter paper, rinse the surface tested with demineralised water.

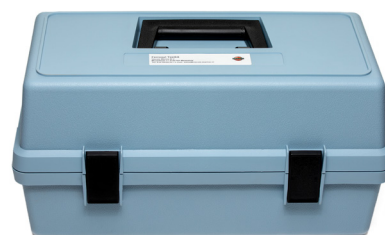
- 1 plastic measuring scoop
- 1 plastic mixing bottle 100 ml
- 1 transparent measuring tube 25 ml
- 1 transparent drop bottle 30 ml
- 1 pack with 100 filter papers \varnothing 11 cm
- 1 demineraliser bottle 177 ml

- Ferroxyl Reagent I - 30 grams
- Ferroxyl Reagent II - 250 ml
